Contract Report CHL-97-4
December 1997

Debris Control at Hydraulic Structures in Selected Areas of the United States and Europe

*by N. Wallerstein, C. R. Thorne, University of Nottingham
S. R. Abt, Colorado State University*

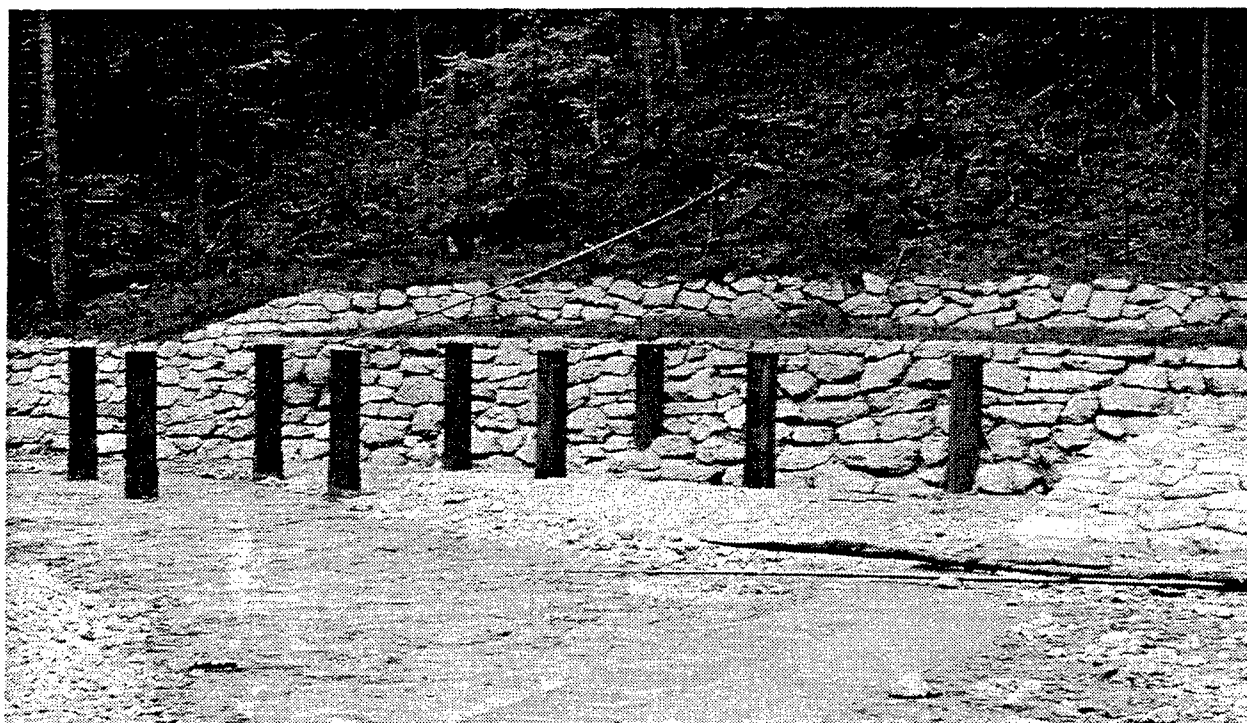
Plate 3 : Treibholzfang device on the river Lainbach. View downstream

The prototype structure on the Lainbach was completed in 1993 and was, at the time when visited (October 1995), being cleaned of a large sediment bar deposit which had accumulated upstream of the posts. The device on the Arzbach is currently under construction. The estimated cost of the device on the Lainbach, without maintenance costs, is DM 2 million (\$1.5 million). Plates 3 and 4 show the prototype device on the Lainbach.

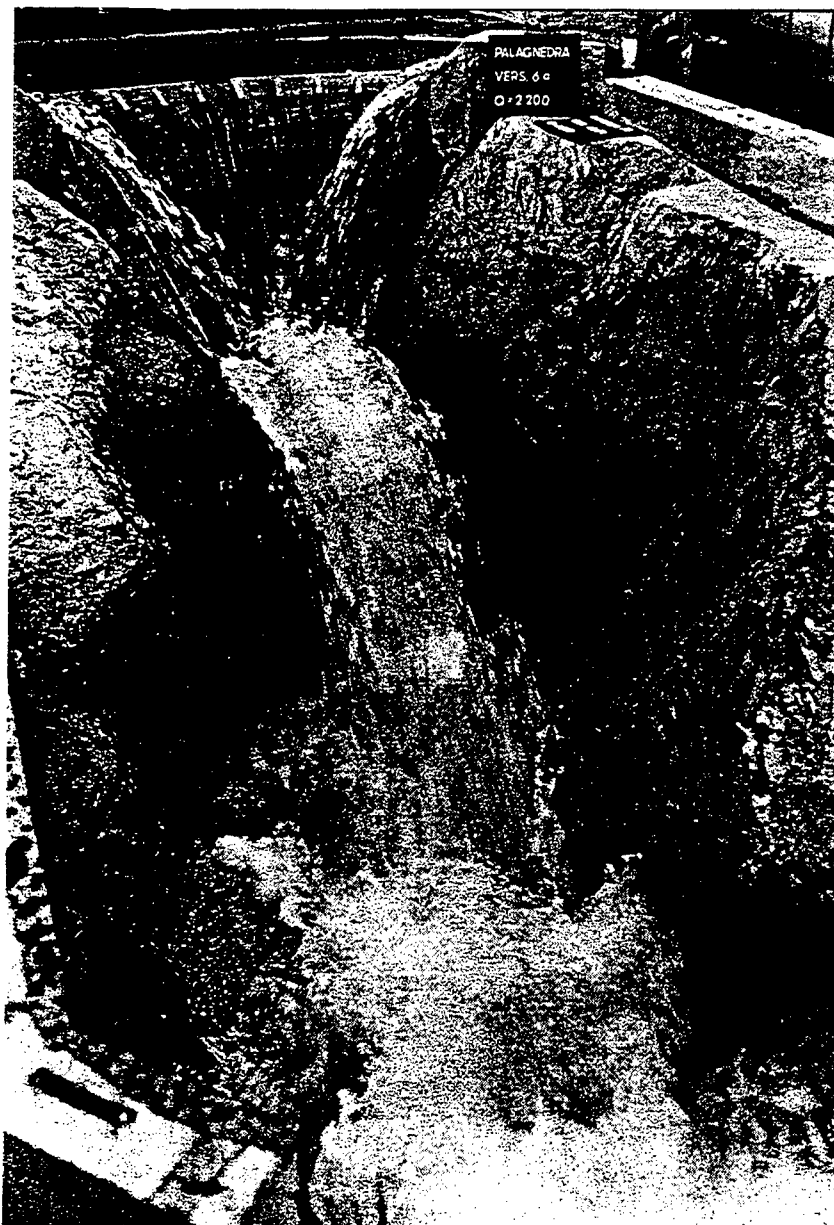
Plate 7 : Physical model (scaled 1:50) with remodelled spillway. Discharge $2.200 \text{ m}^3/\text{s}$ (after Vischer & Trucco, 1985)

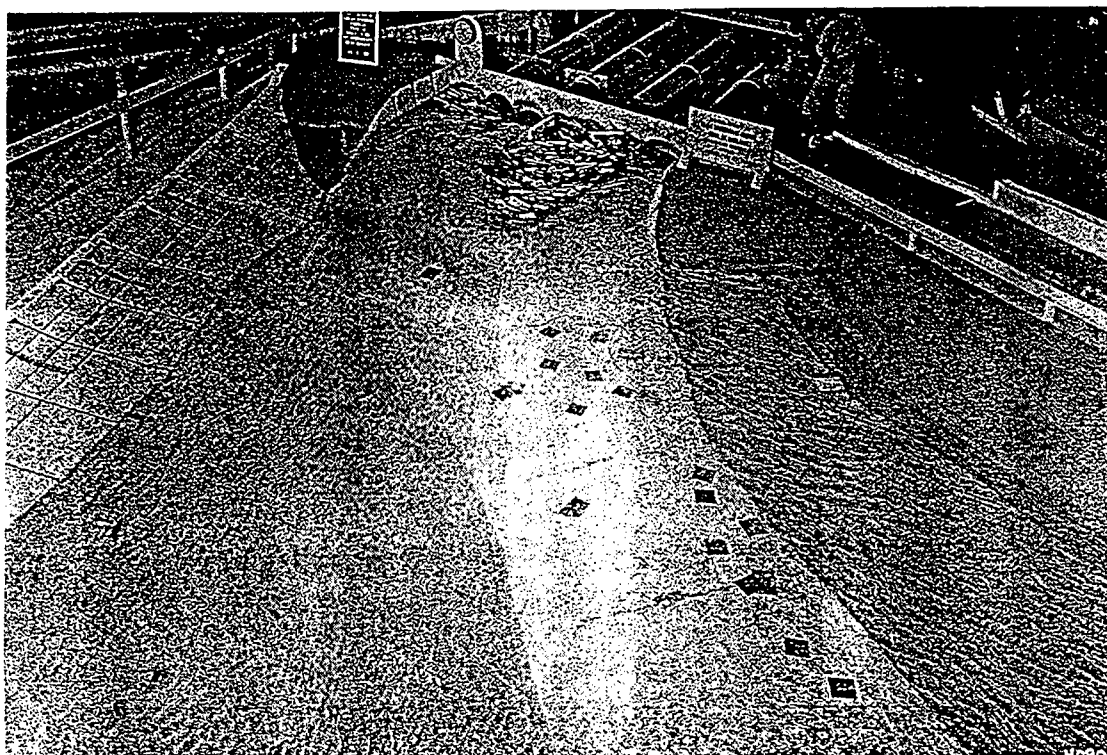
Plate 11 : Test Run Using Standard Project Flood and Debris Load (from Martin, 1989)

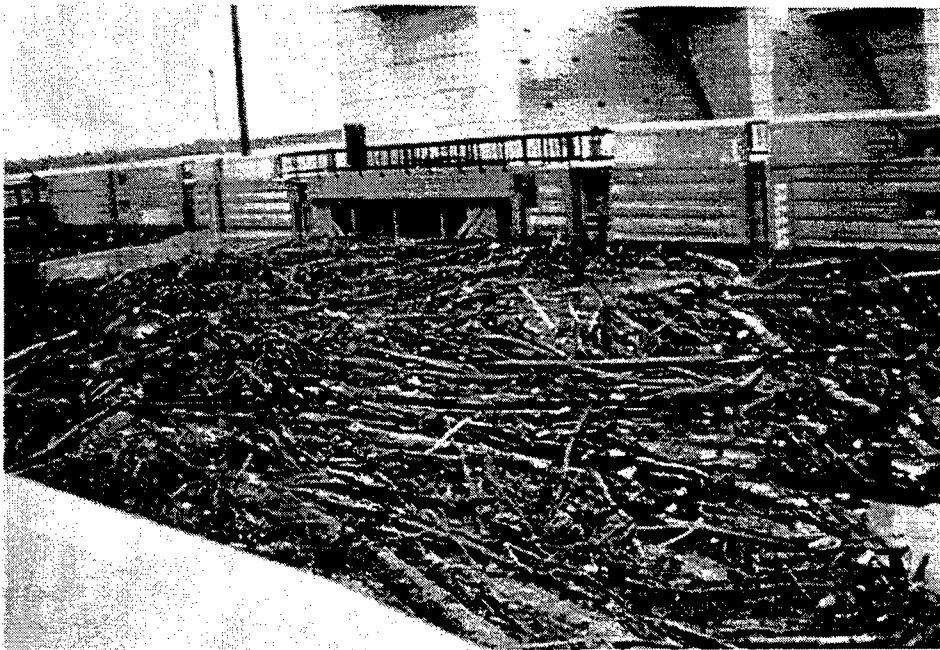
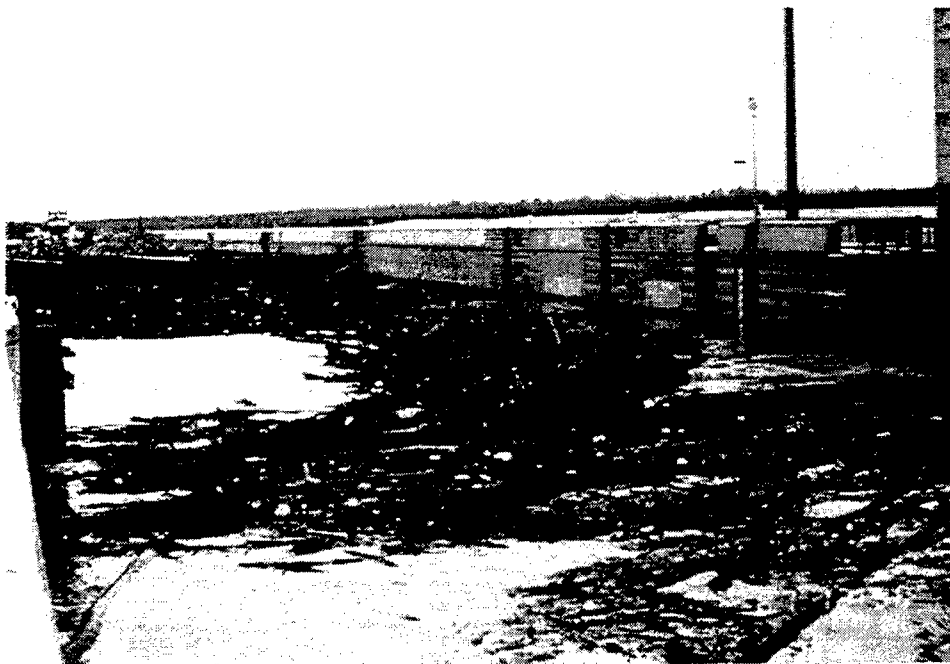
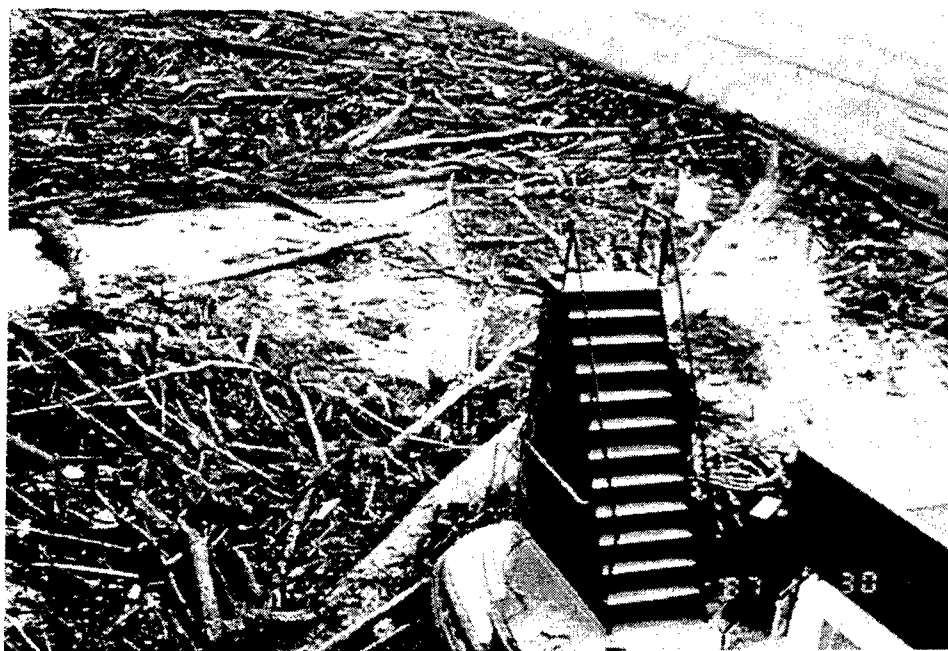
Typical log jam, Lock and Dam Operation

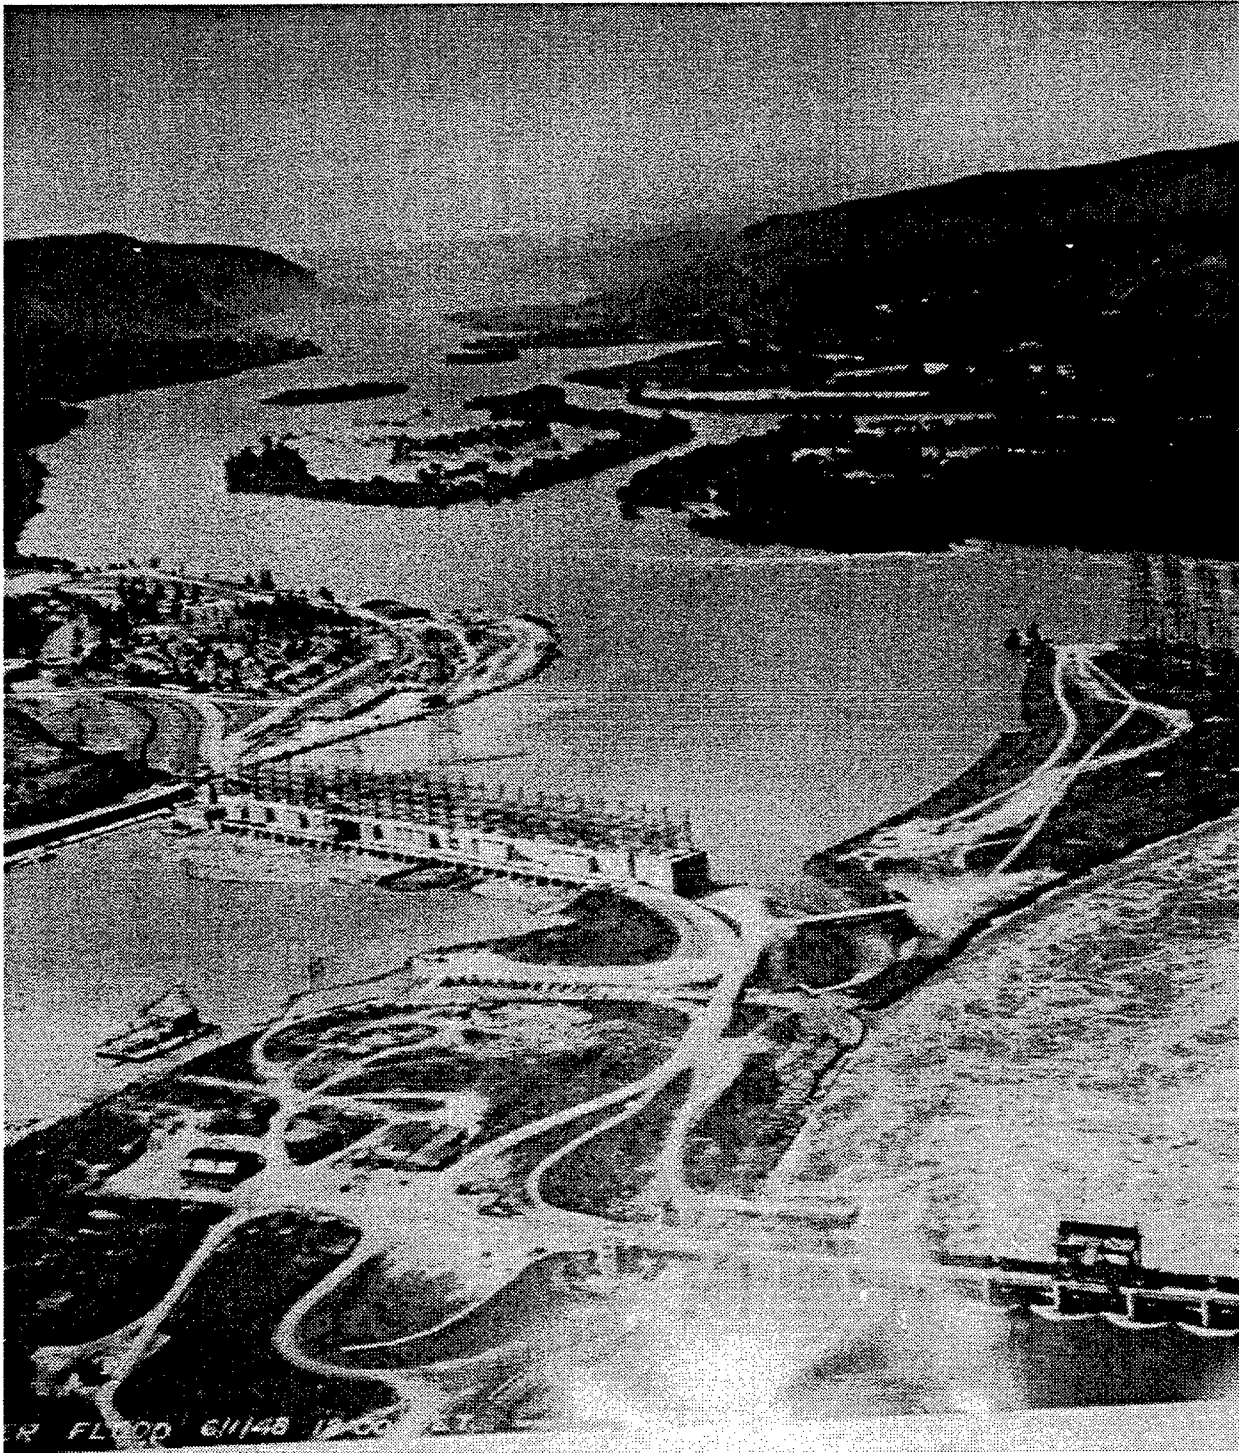
Bonneville Powerhouse No. 1 with debris jam in 1948
